Lot #123, 123 Any Street, Any town, TN

A+ HOME INSPECTIONS

HOME INSPECTION REPORT

Evaluation of property located at: **Lot #123, 123 Any Street, Any town, TN**

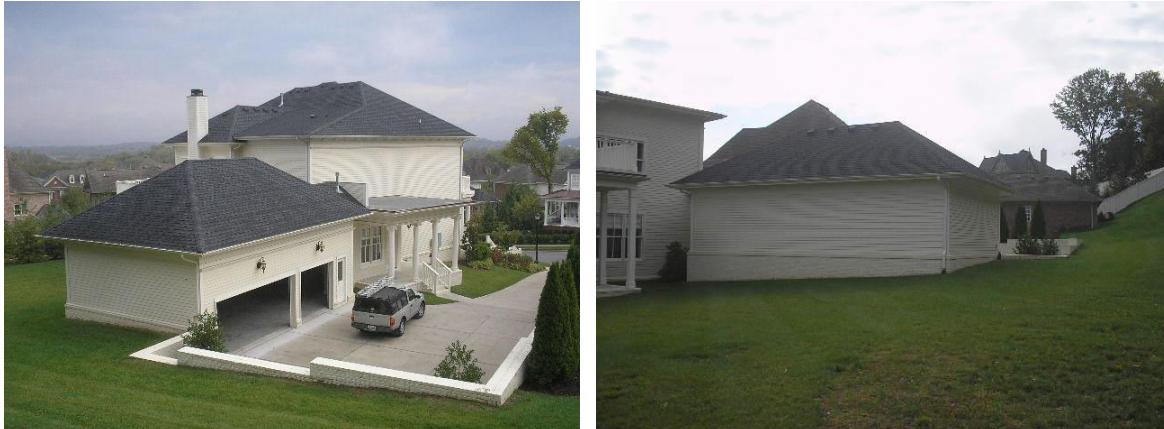
2. This home is built on a lot, which slopes steeply from rear left to front.
3. Ground slopes down toward the back of the house; like at the back of the breakfast area and garage where water has entered before.

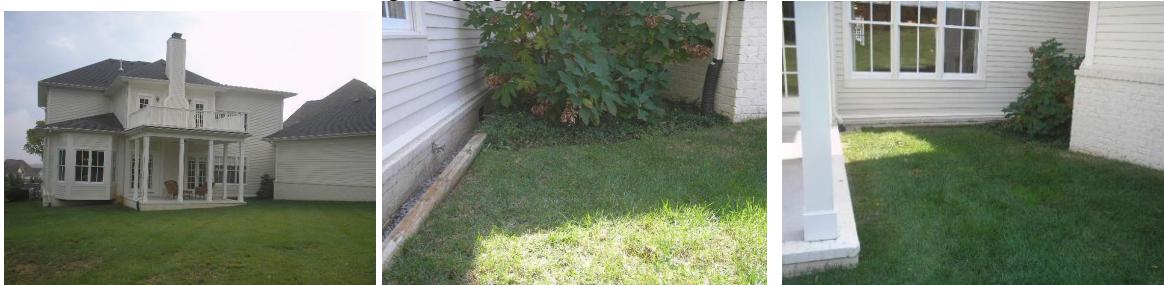
- 4.
5. The ground should slope away from the house continuously at least one inch per foot for ten feet minimum. But, it is flat right up against the house in places on all four sides.

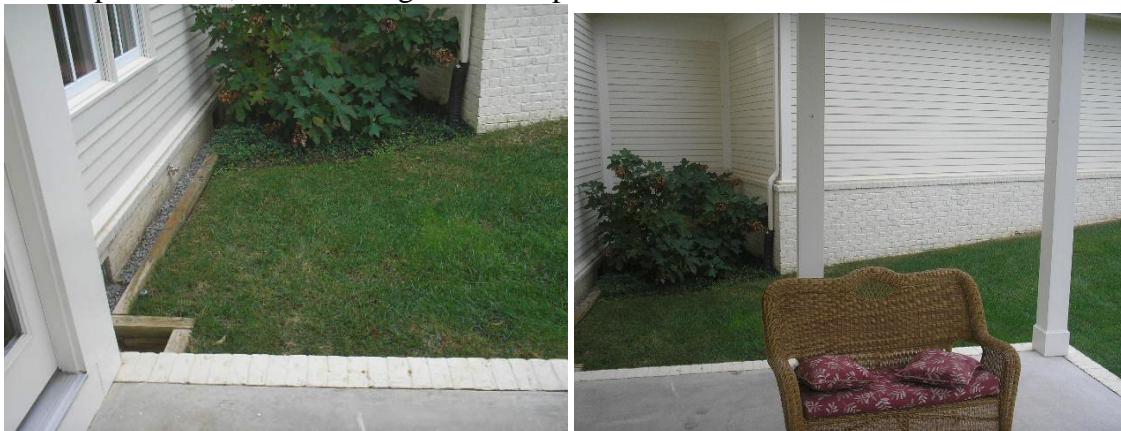
- 6.
7. The trench is flat along the back of the breakfast area with dirt right up to the bottom of the crawl space vents, with a little gravel on top.

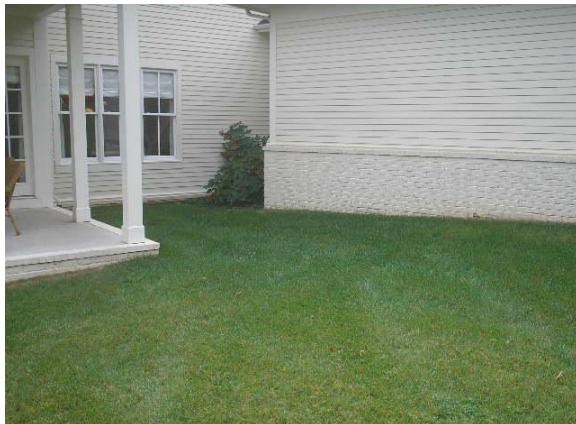
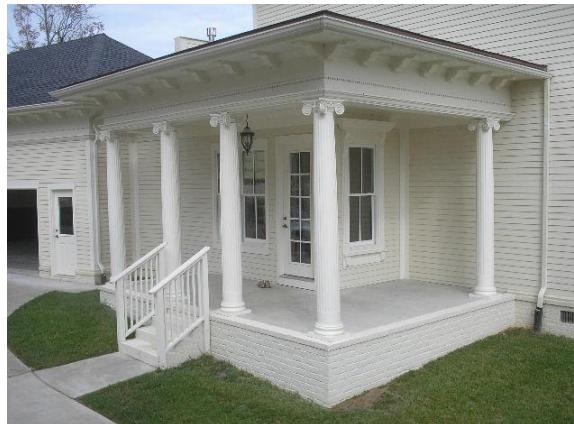
- 8.
9. Ground should slope AWAY from the house.
10. It is important that roof and surface water drain away from the foundation to properly maintain the integrity of the foundation and maintain the area under the home. This includes keeping gutters and downspouts clean, and maintaining downspout extensions and splash blocks.

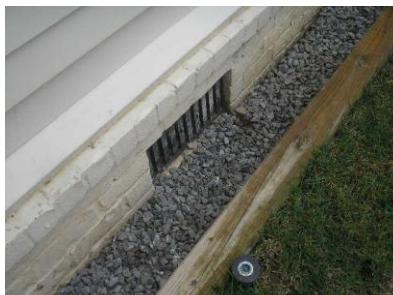
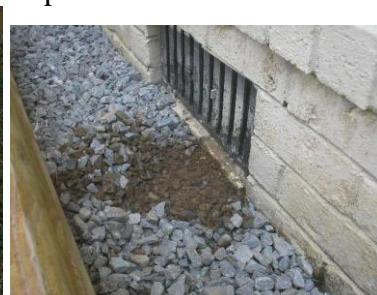
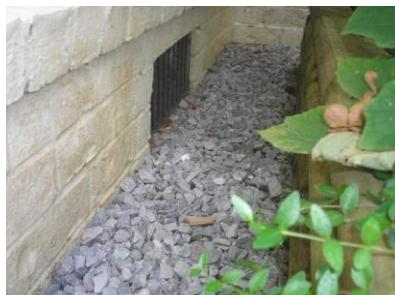
11.
12. Water could run into these crawl space vents.

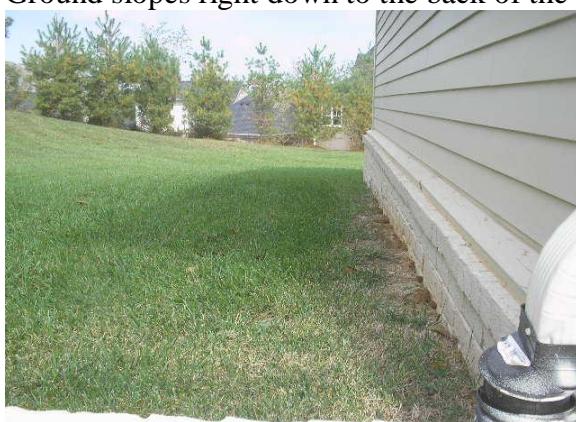
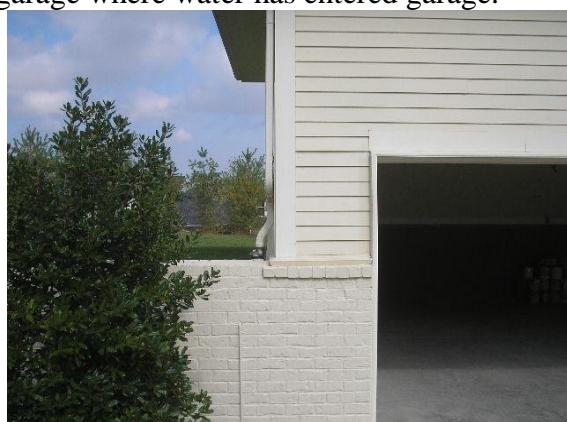
13.
14. Building codes 401.3, 406.3.5 and 1806.5.5 require the ground surface to slope AWAY from the foundation 6" minimum drop in 10'-0" of horizontal distance. It is recommended that the ground slopes away from the house at least 1" per foot for at least 10'-0".
15. Ground slopes right down to the back of the garage where water has entered garage.

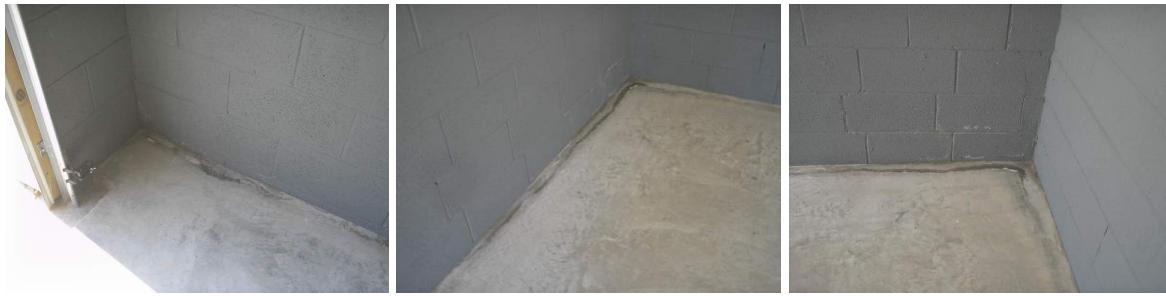
16.
17. It is wet along this rear wall in the garage at this time.

19. Adding sloping compacted clay dirt up against house to any low lying areas around the foundation where ground settles, will help kick water away from house.

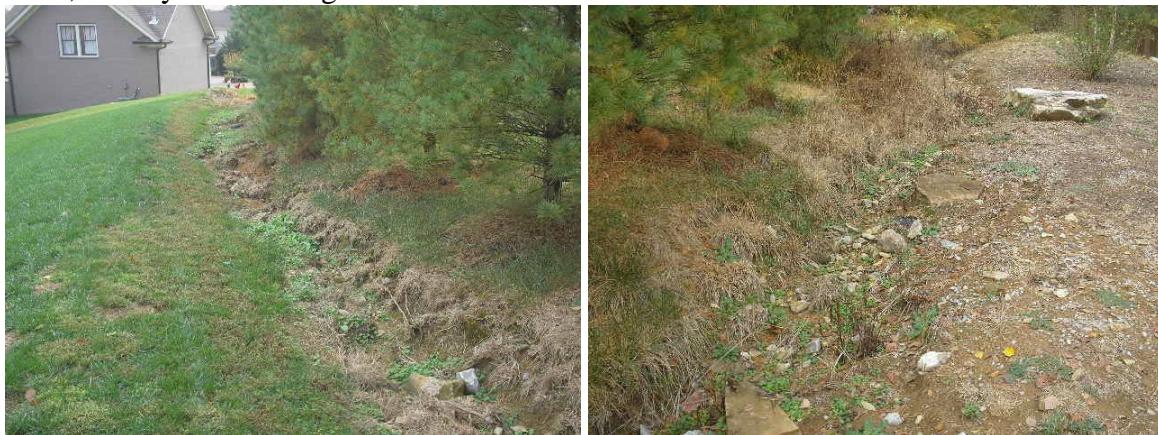
25. Water is standing in the ditch along the right side property line where some downspout extension pipes dump out. The erosion in this ditch needs to be corrected.

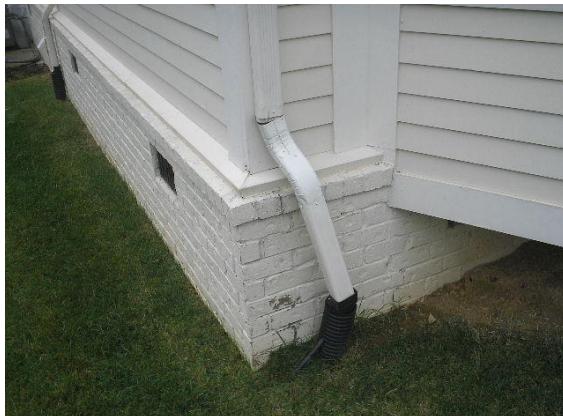
1. What is the pipe going into the side of the rear right downspout extension pipe for? It looks like a lawn irrigation line that may have been cut in two when down spout extension was installed?

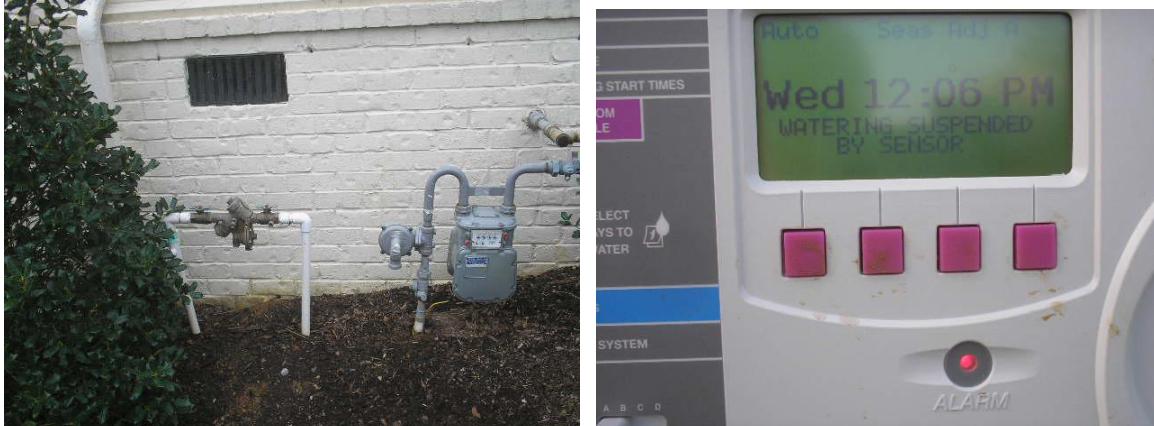
1. Lawn irrigation system is beyond the scope of our inspection. It was not tested or inspected.
2. Backflow preventer on the lawn irrigation system is dripping at this time. It is on the right end of the house.

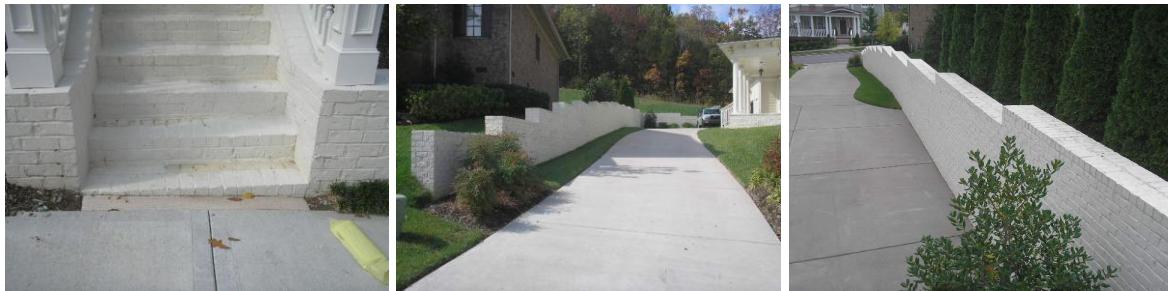
1. Front bottom brick step is a trip hazard where it meets the sloping front sidewalk. Its step up varies from about 1" high to about 4" high.

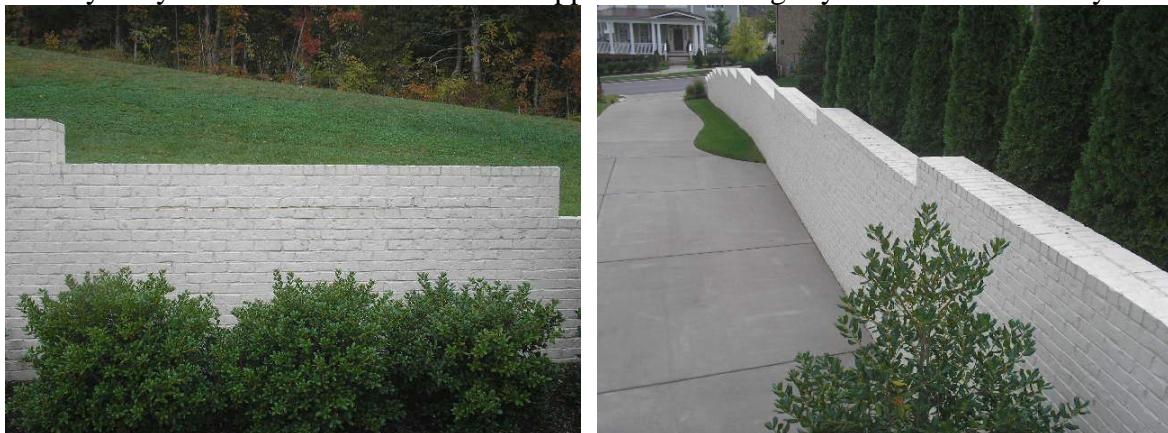
- 2.
3. Brick retaining walls are about six feet high without protective handrails.
4. I don't see any weep holes in any of the brick retaining walls. Some are about six feet high with no weep holes in them.
5. Top four courses of brick on the retaining wall at the rear of the parking appear to have been hit maybe by a lawnmower. This section appears shifted slightly toward the driveway.

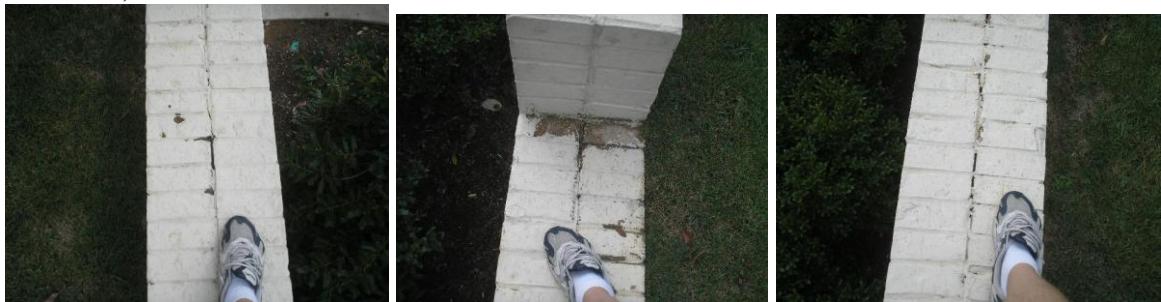
- 6.
7. Other cracks noted in the brick mortar joints on the brick retaining walls.
8. There are several open mortar joints in the tops of the brick retaining walls where moisture can enter, freeze and crack the bricks loose.

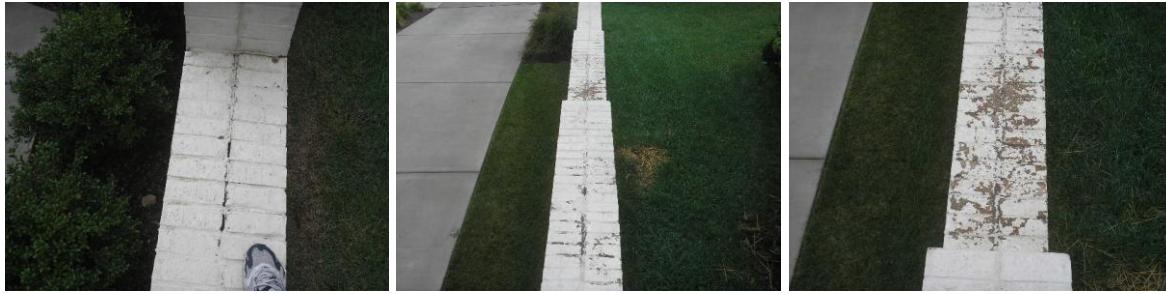
- 9.
10. Brick retaining walls are flat on top and do not have stone or concrete caps on them to shed the water off them.

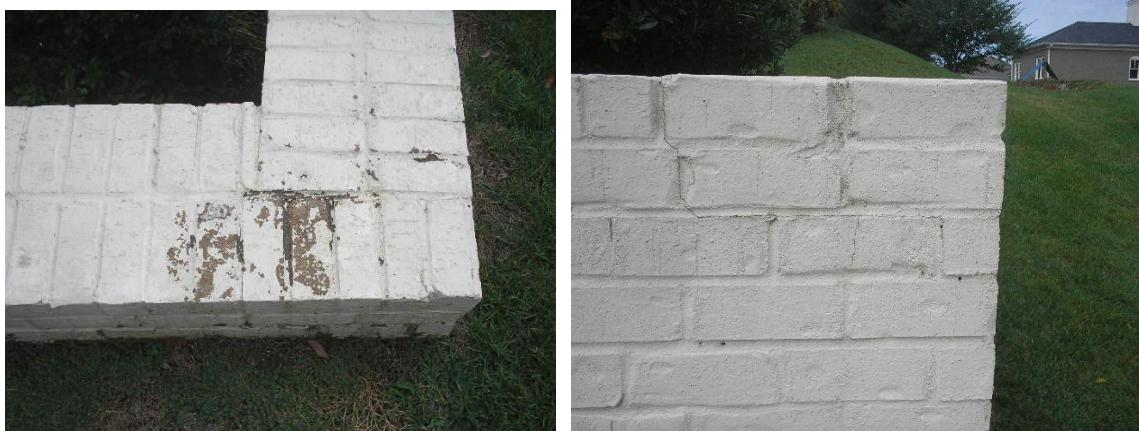
11.
12. Brick is porous and allows water to soak into it.

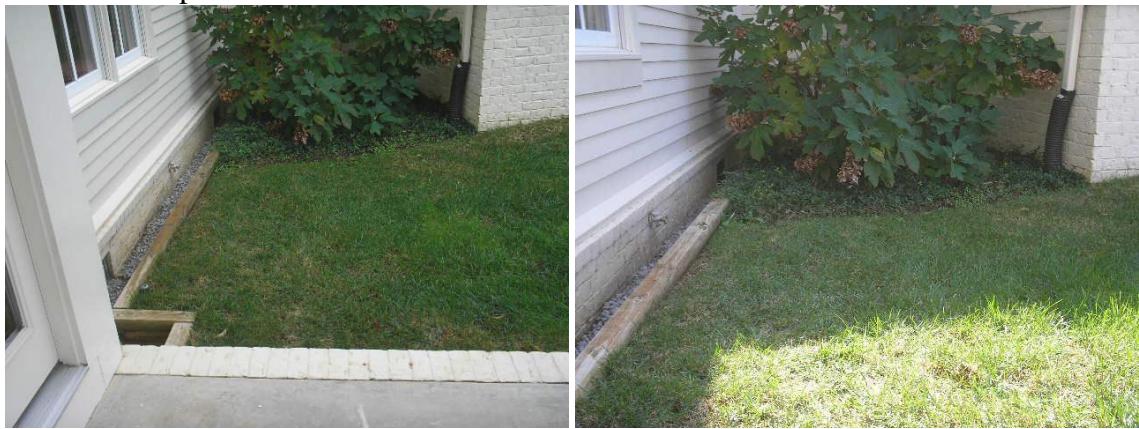
13.
14. A lot of paint has come off the tops of the brick retaining walls. There was probably water in the top of the brick walls when they painted them.
15. Some paint has come off the bricks at the rear porch too.
16. Common cracking noted on concrete driveway and walks.
17. There are Sentricon termite bait stations on the ground. Were termites found? Is there a transferable warranty?
18. Wood landscape timbers are installed in the ground along the rear of the house to form a short retaining wall near the back of the house. I often find termites in these type of landscape timbers on other homes. I recommend replacing these wood timbers with a brick wall to avoid problems here.

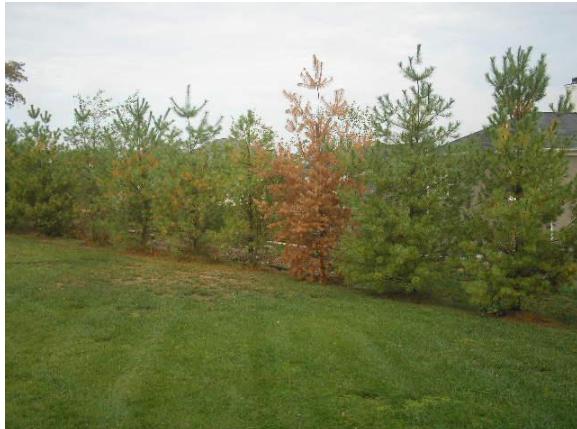
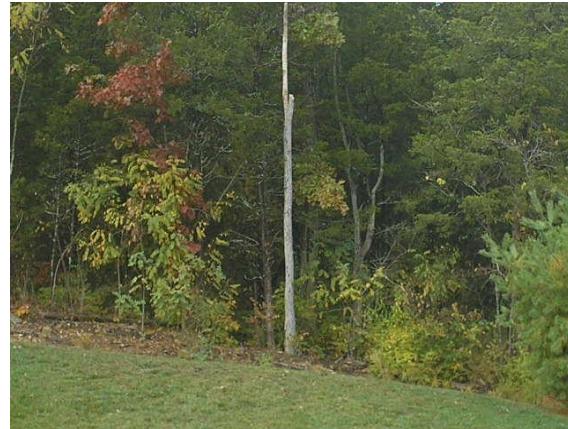
19.
20. Replace dead trees and shrubs.
21. There is a dead pine tree at the right side of the rear yard.

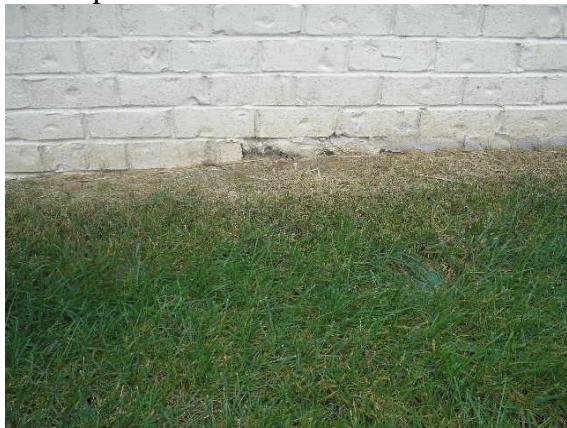
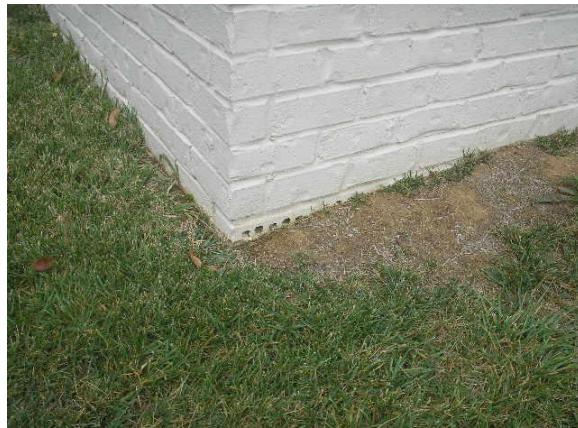
22.
23. Dead tree noted at the rear ditch near the right corner.
24. Ground doesn't cover some bottom brick scraps along the right side of the garage. There is some space where there is not brick.

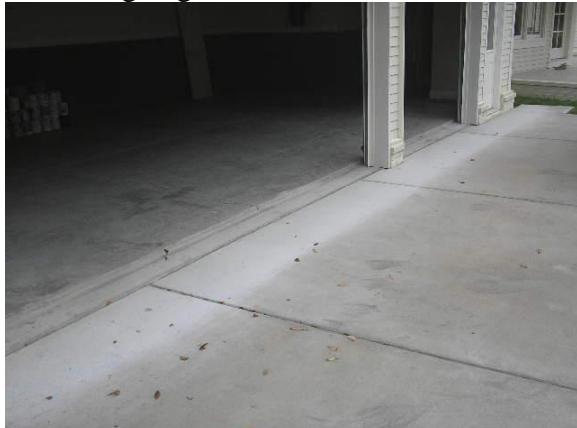
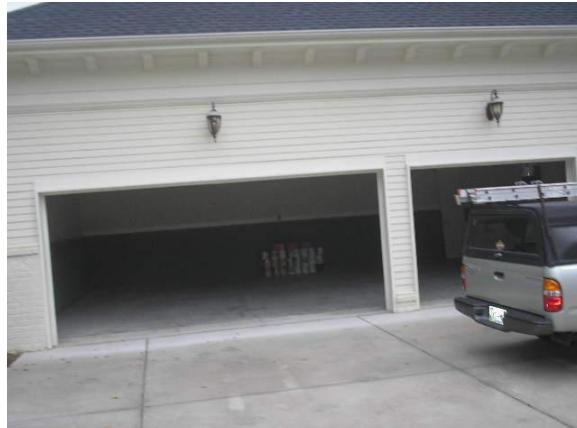
25.
26. Concrete slab outside of the garage doors appears to have paint overspray about 2 feet out from the garage doors.

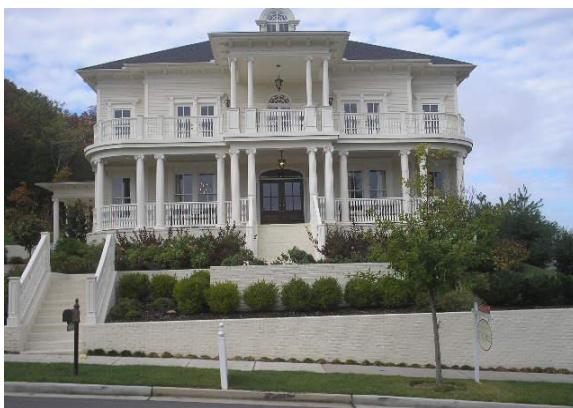
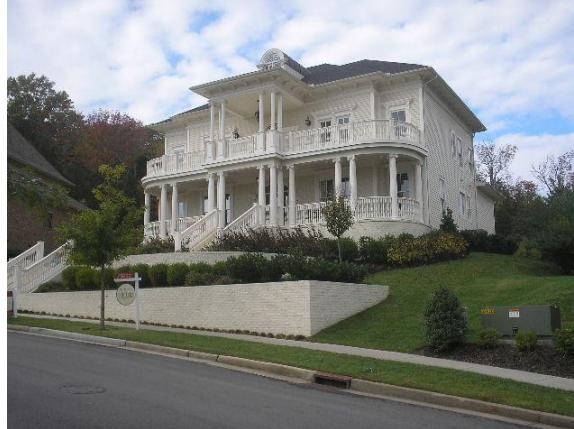
27.
28.
29. All shrubs should be trimmed at least 12" to 24" from the house to allow proper air circulation around the walls and HVAC units. Vines and other climbing plants can damage exterior surfaces by trapping moisture and by promoting another path for insects to enter the home. I cannot see some of the exterior due to bushes covering it.

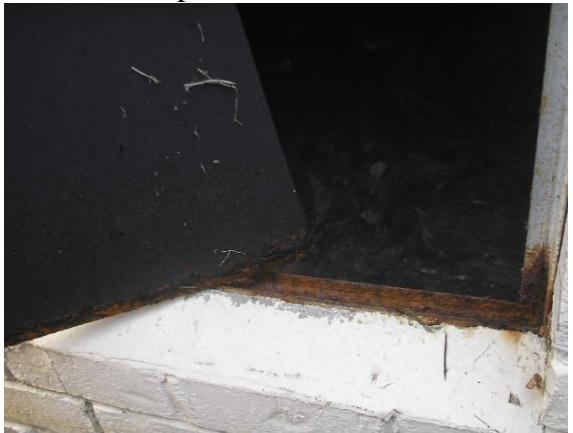
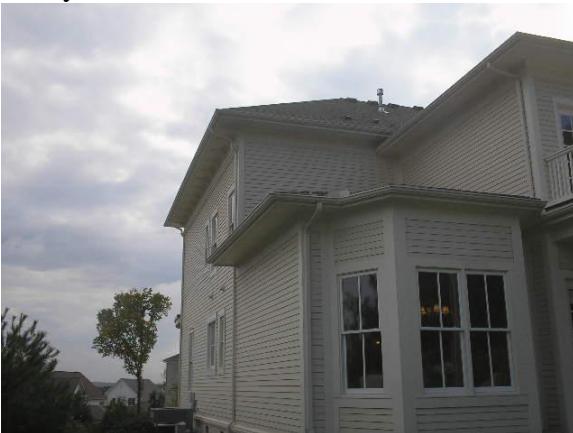
1. Metal crawl space door and frame are rusted badly.

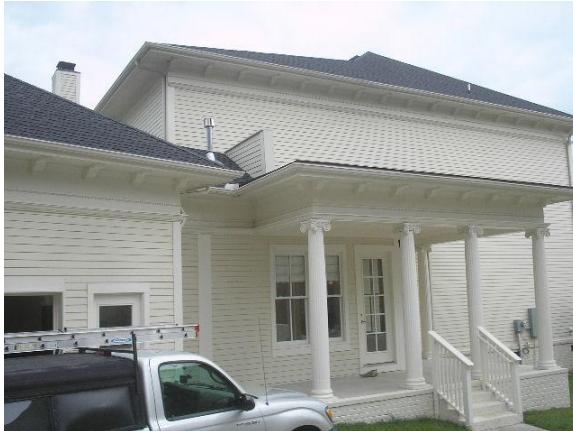
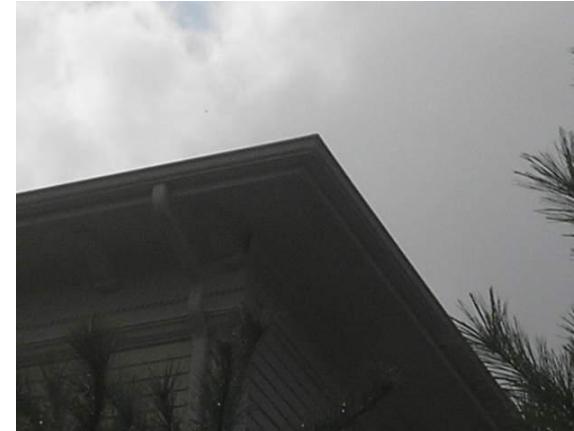
3. Corbels under the soffit/eave go all the way down the left side of the house as seen from the street, but they do not go all the way down the right side. They are missing from the right side of the master bedroom as seen from the street.

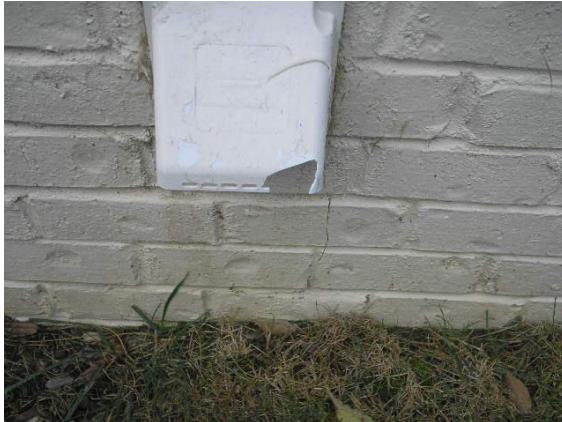
5. On the rear right corner of the upstairs, the crown molding ends without a return on it. Birds can enter behind this whole piece of crown molding here.
6. On the right outside of the house, a vent hood has a piece broken out of it.

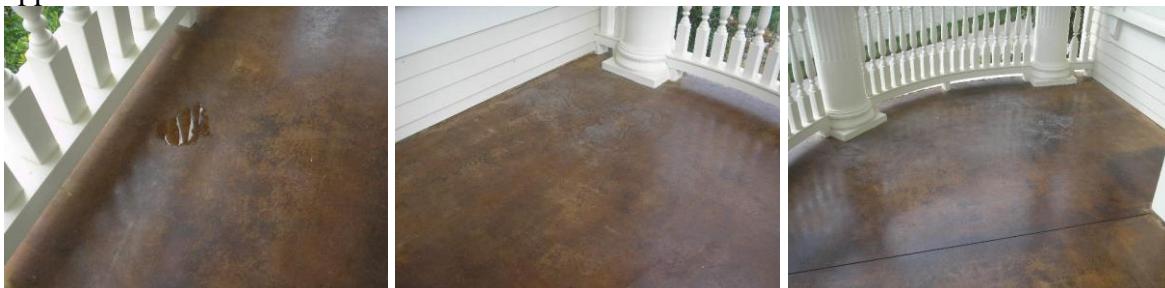
9. Water stains noted where water puddles on the both ends of the front concrete porch. Water appears to stand here.

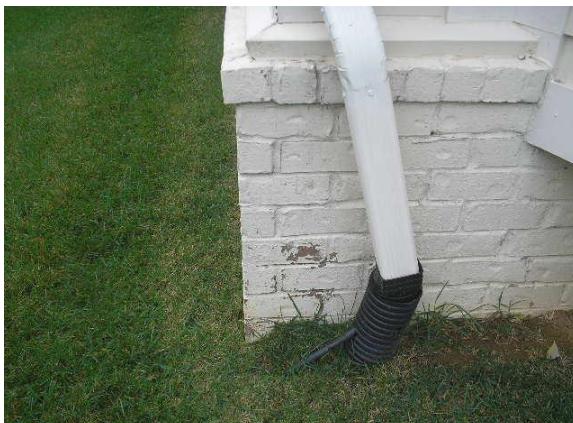
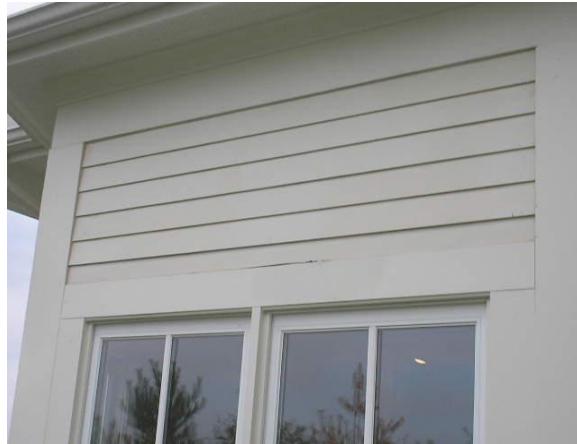
- 10.
11. There is a water puddle now on the front concrete porch to the left of the front stairs. It rained last night.
12. Some paint has come off the bricks on the rear corner where the downspout is pulled is loose and the downspout extension has settled into the ground. Fix the downspout, clean, prime, and paint the bricks here.

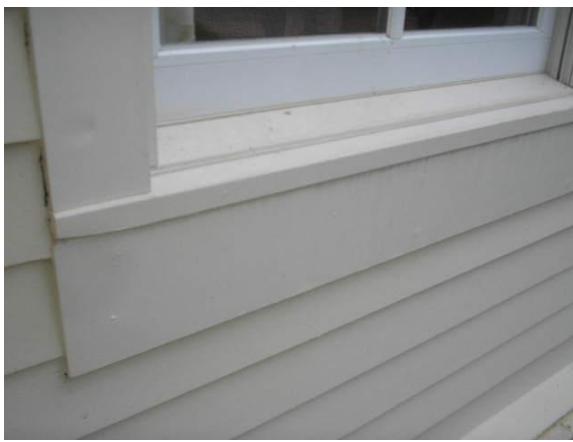
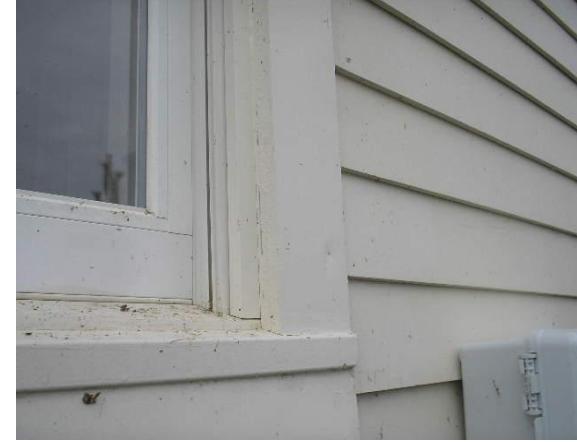
- 17. There are open saw cuts in siding around some windows, like on the rear breakfast area and bonus room.

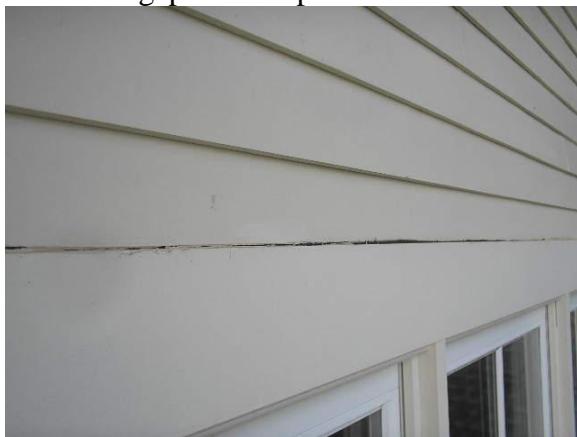
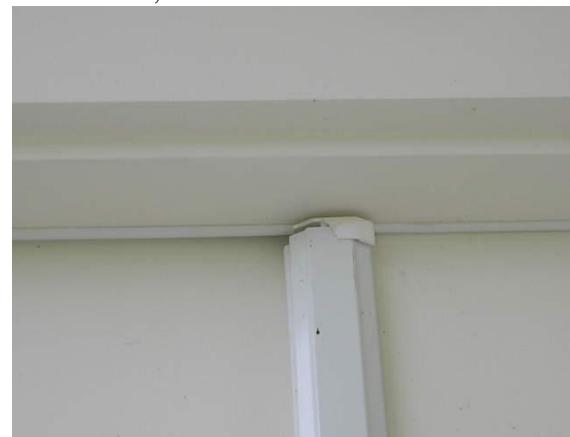
20. There is a gap at the top of the trim above some windows, like rear bonus room windows.

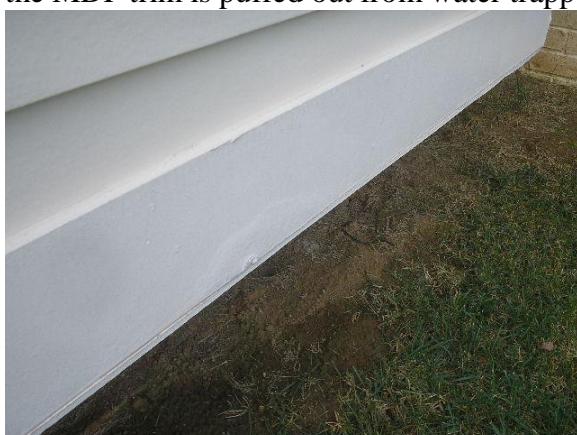
25. Edge of the plywood is showing on the bottom of the rear master bay bump out. The trim usually runs down over the edge of the plywood on the bottom of the bay. This is one reason the MDF trim is puffed out from water trapped here.

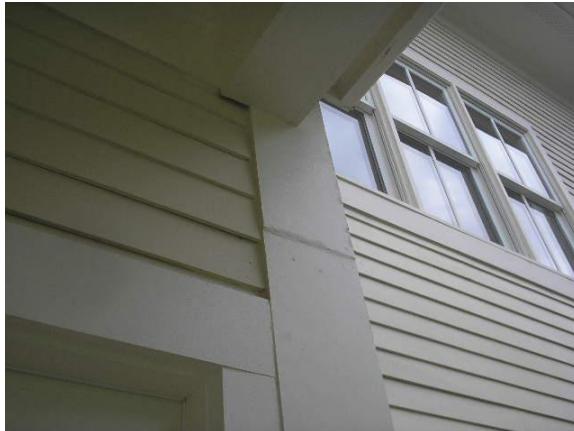
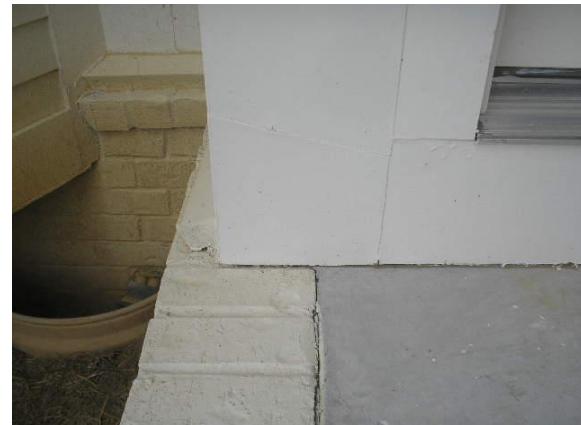
29. Trim is not flush where trim is pieced together above the rear left doors at the rear porch.

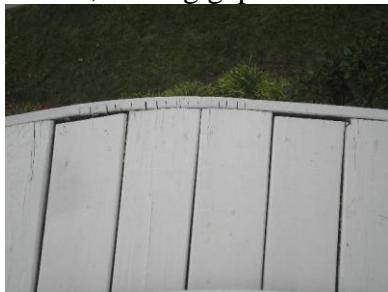
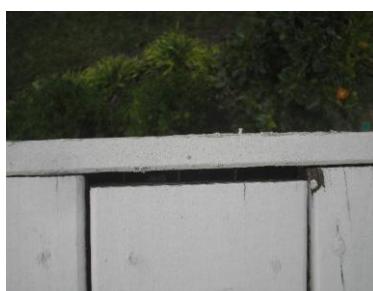
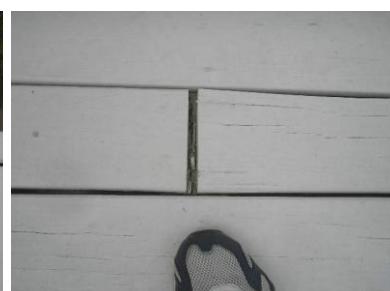
31. Trim is pieced together with a diagonal cut at the bottom right of the right French doors on the rear porch. A full length piece of trim should have been used instead of piecing this together.
32. Common slight waviness noted in the Hardie plank siding. Some butt joints have been caulked.
33. All the window screens are missing.
34. On left end of front balcony, some nails are backed out of the trim on the end of the floor boards, leaving gaps.

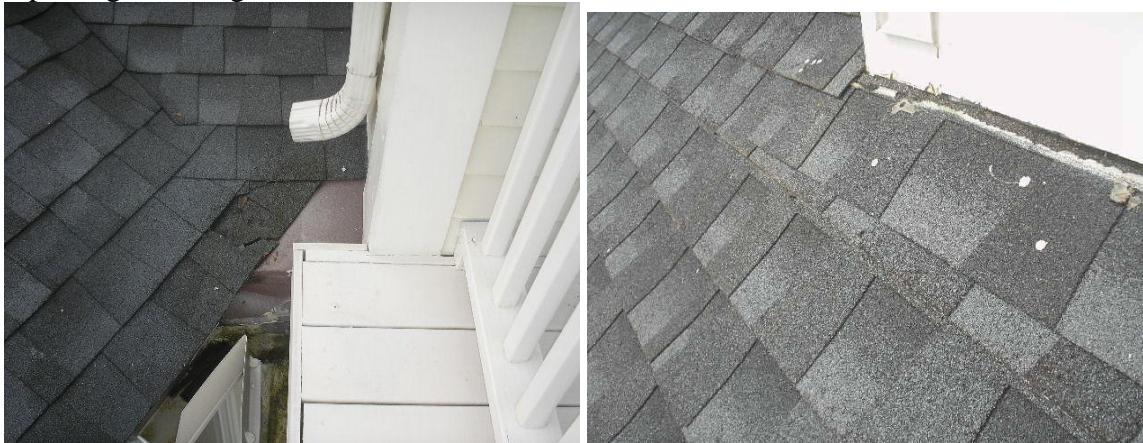
1. Roof shingle is torn on the front right corner of the rear balcony where the downspout dumps out. I recommend extending this downspout over into the gutter where the shingle is split and replacing the shingle.

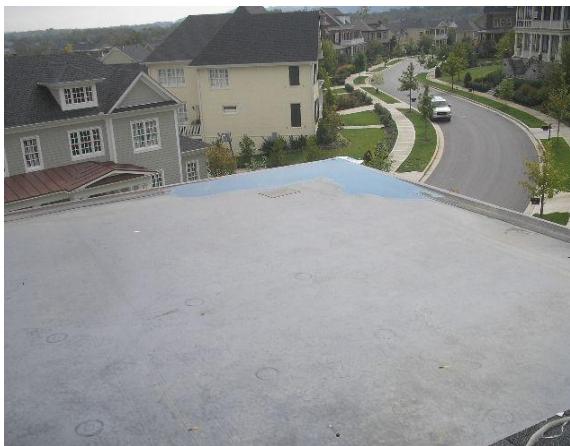
- 10.
11. On the rear roof, the second box vent from the front is crushed.
12. I cannot see the roof under the floor planks on the front and rear balconies.
13. Water is standing on the membrane roof above the front balcony and left side porch at this time.

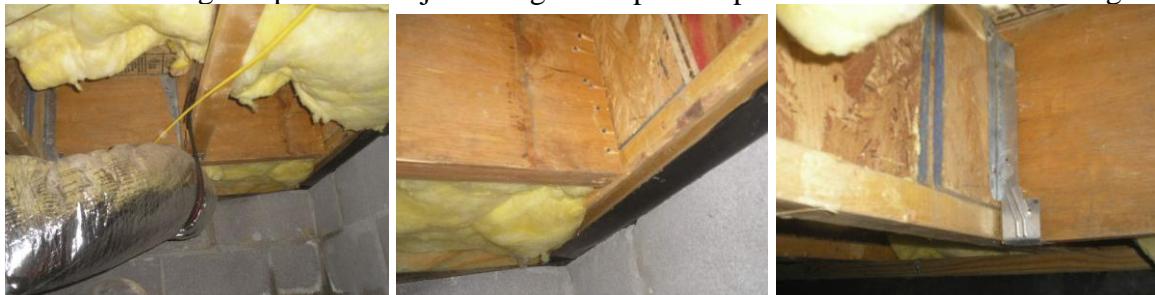
1. In the front left crawl space, one floor joist is cut completely in two for a piece of ductwork. A metal Simpson joist hanger has been put on one end of the header but not on the other. Add the missing Simpson metal joist hanger and put Simpson nails in holes of the hangers.

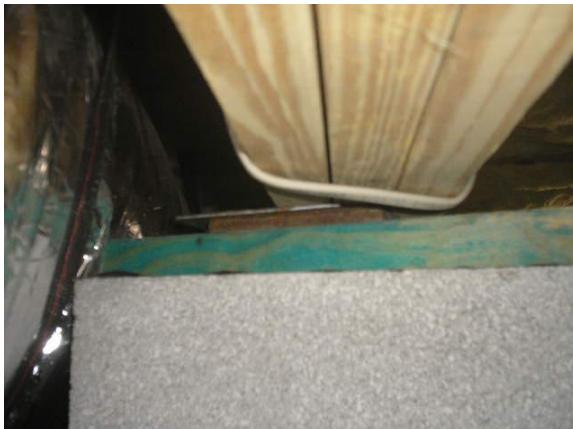
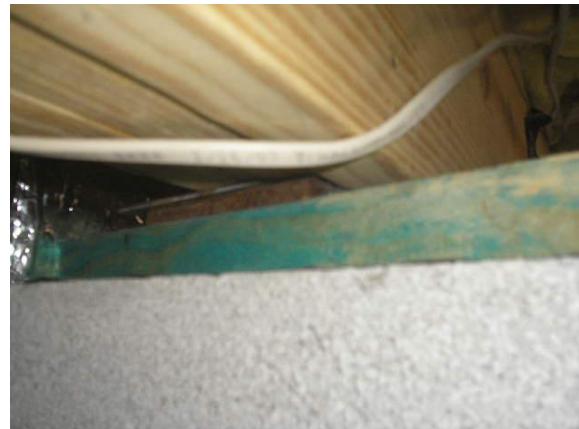
- 2.
3. At the second pier closest to the crawl space access door, the steel shim plates are not positioned under all three members of the 3-ply girder beam. This can cause separation of the beam. Full bearing of the wood girder beam is needed on its steel shim plates. Move the electrical wire out of the way and add more steel shim plates or tap these over under so they are fully under the beam.

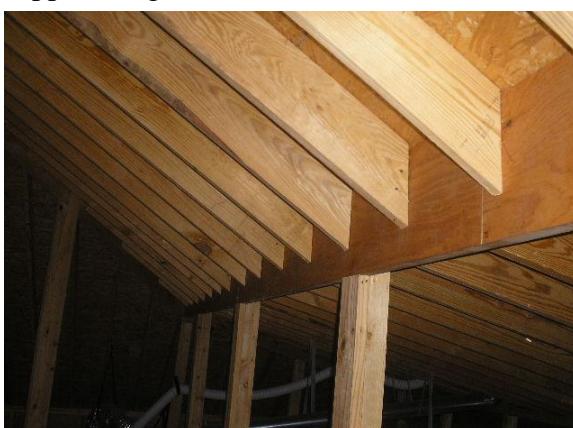
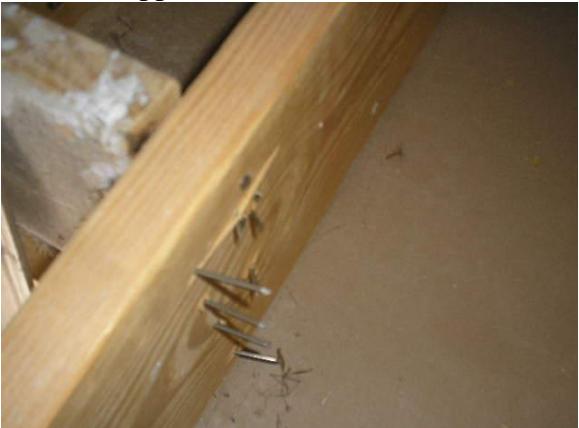
- 6.
7. In the upper attic, the upper rear roof rafters are just toe-nailed at their bottoms. Add a 2x4 support ledger across their bottom ends which are not supported at this time.

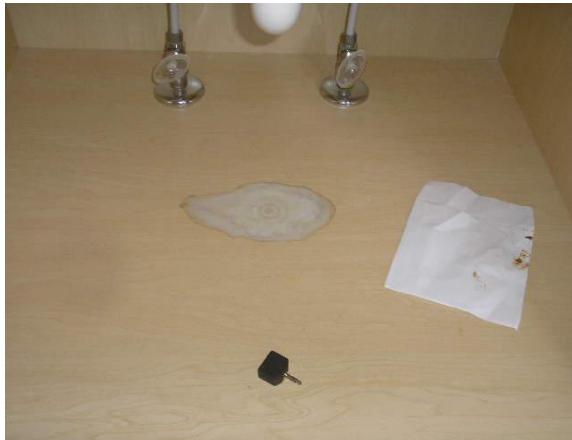
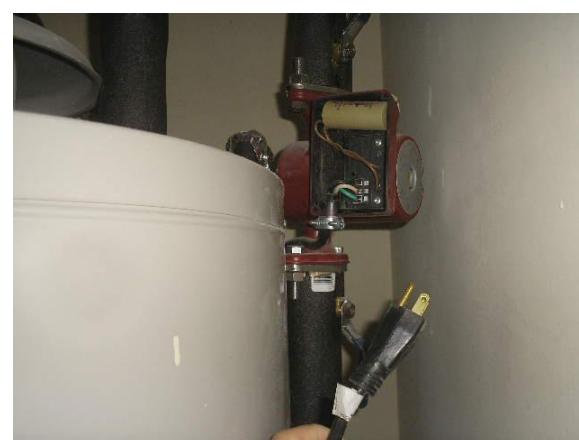
1. There has been a leak under the master bath sink. There is a spot on the bottom of the cabinet. Ensure leak has been fixed.

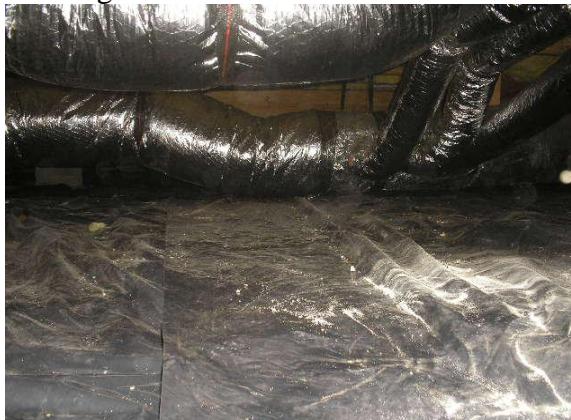
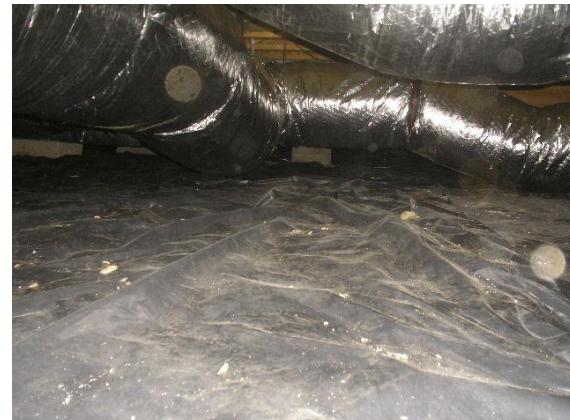
2. Main supply air duct is lying on the ground in the center of the crawl. It should be at least 4" off the ground.

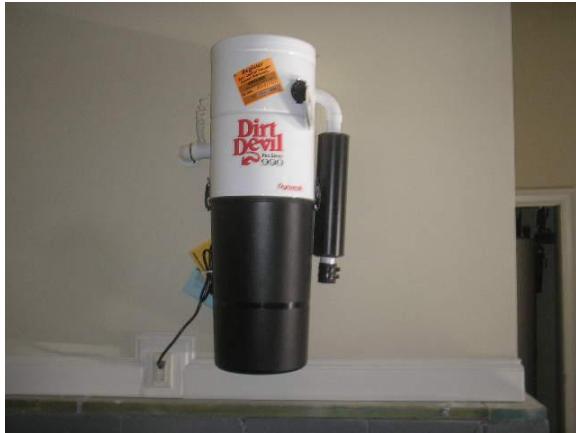
- 3.
4. Central vac in the garage should vent to the outside not into the garage.

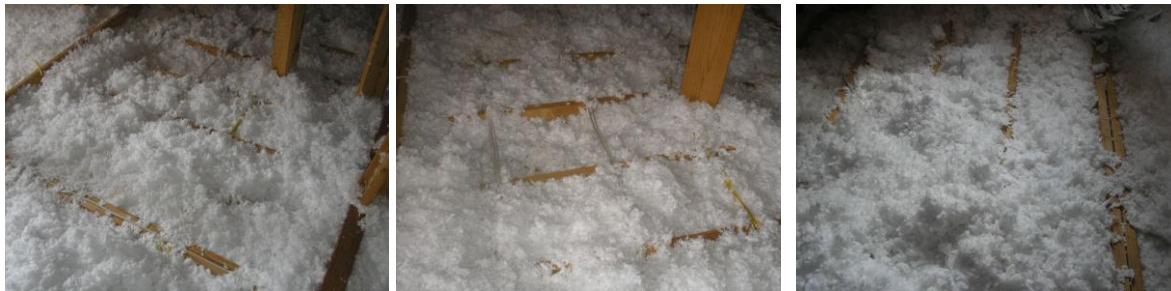
1. There are no roof vents or access into the attic above the master bedroom and there should be.
2. Ensure bath exhaust fan hoses are permanently attached to vents through roof.
3. Sharp nails are sticking through the top of the pull-down attic stairs where the trim is shot on.
4. Sharp nails are sticking out around the attic access.
5. There needs to be more insulation in the attic. Tops of ceiling joists are showing in places like in the front attic.

- 6.
7. Add more blown insulation in attic. Where tops of ceiling joists are showing, insulation is only about 7" deep. Attic insulation should be about 13" of loose fill for a desired R-38.
8. Typically, blown insulation should be kept at least 3" away from any recessed can lights unless the lights are rated for IC (insulation cover). I usually cannot tell if the can lights are rated for IC or not.
9. FYI- Exterior wall insulation is not visible, therefore, cannot be inspected.
10. FYI- Soffit and roof vents noted. Proper roof ventilation extends the roof's life and prevent internal sweating and excessive heat build-up.

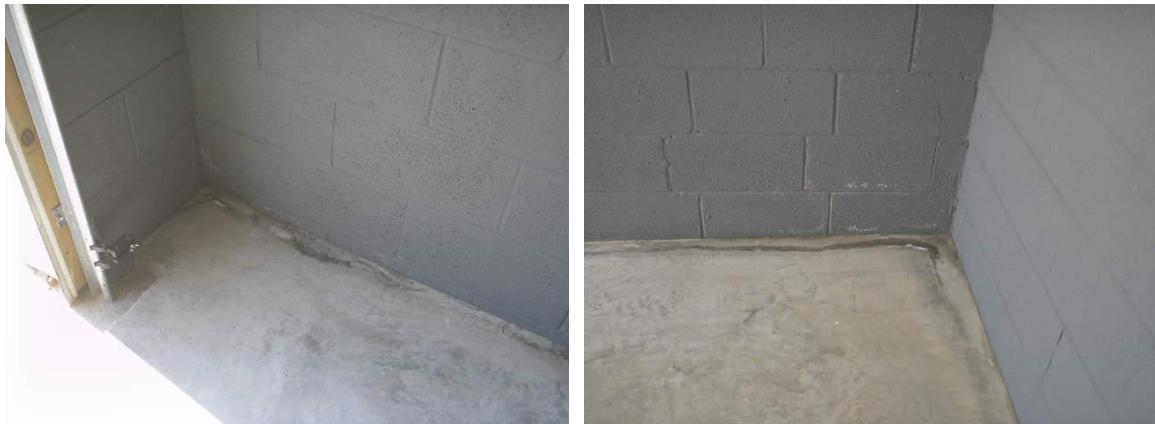
1. Water stains noted on the concrete block walls and concrete floor slab in both rear corners of the garage.

- 2.
3. Both of these corners are wet and “peg” my moisture meter at this time. There is white efflorescence on the block wall here. Efflorescence typically occurs during the initial curing of masonry construction, particularly brick, when water moving through a wall or other structure, brings salts to the surface. As the water evaporates, it leaves the salt behind, which forms a white, fluffy deposit, that can normally be brushed off.

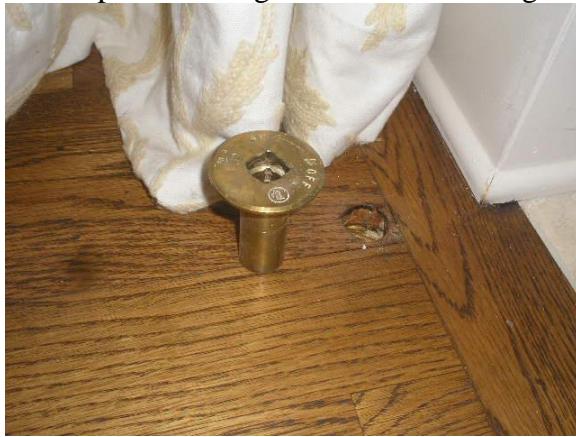
1. A lot of wasps fell and flew out of the fireplace flue pipe when I opened its damper. Seal it where wasps cannot enter. Check this wood burning fireplace flue pipe for separation.
2. Brass gas floor valve needs to be screwed together in the floor. Someone has to push the valve up so the flange can be screwed together like it should be.

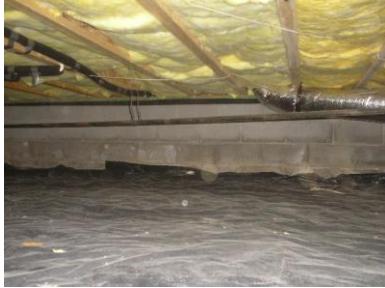
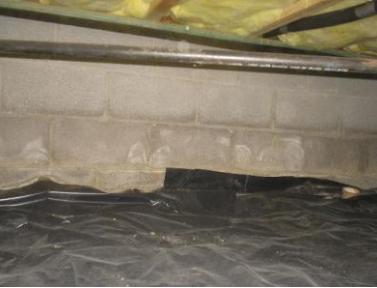
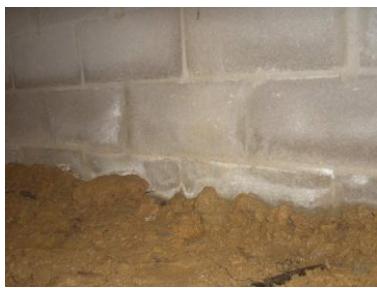
5. Ground is soft and muddy in back of crawl space where outside ground slopes down to the trench along the back of the house.

7. Improve the exterior drainage to eliminate dampness in the crawl space as noted under LOT DRAINAGE notes at the beginning of this report.
8. Some drainage contractors add a French drain along the perimeter foundation walls either inside or outside of the crawl space.
9. Common dampness on ground around the rest of the perimeter foundation walls in the crawl space.
10. There is a positive drain in the front right corner of the crawl. It has NO water standing at it at this time.
11. A temporary wood board needs to be removed from the left crawl space wall. It is wet and touching the dirt. This invites termites.
