Lot #123, 123 Any Street, Any town, TN

A+ HOME INSPECTIONS

HOME INSPECTION REPORT

Evaluation of property located at: **Lot #123, 123 Any Street, Any town, TN**

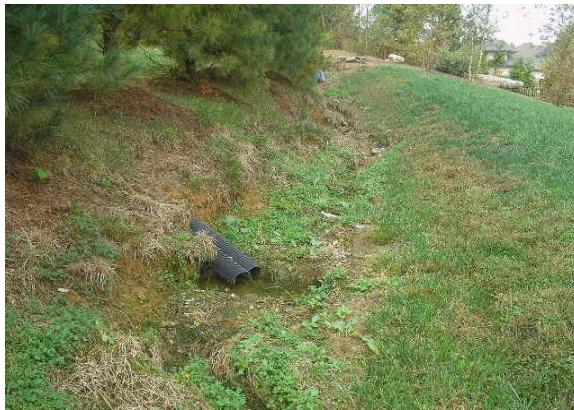
24.

25. Water is standing in the ditch along the right side property line where some downspout extension pipes dump out. The erosion in this ditch needs to be corrected.

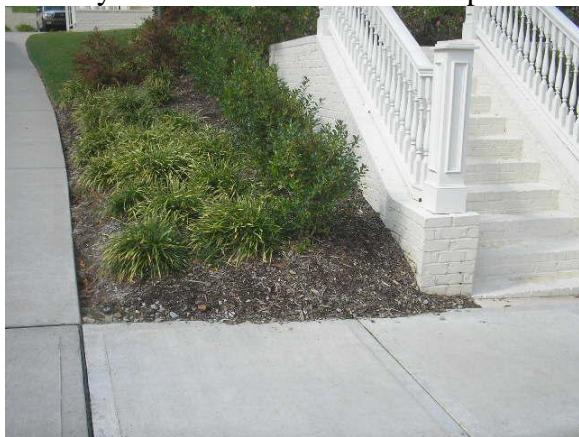
29. Water runs down the right side of the driveway and washes mulch out on the front steps.

30. Water is standing on top of some of the brick steps on porch steps.

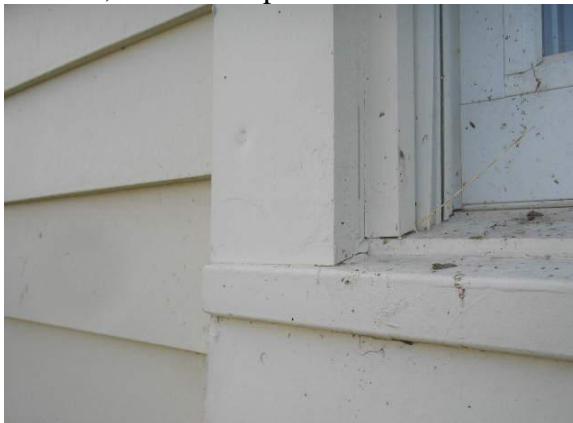
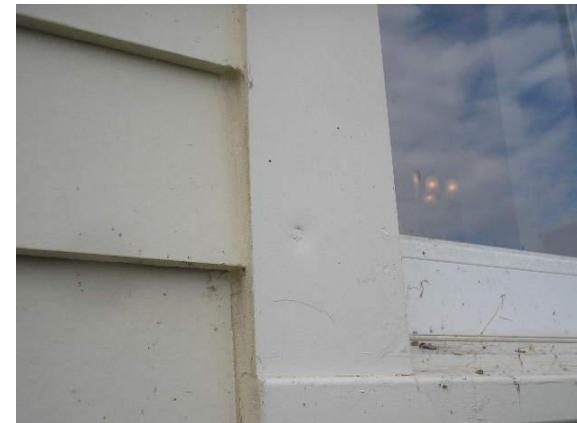
13.

- 14. Paint doesn't match where it has been touched up at the top outside of the rear master bedroom bay window trim.
- 15. Several nails on the outside window trim are dimpled in by a hammer, where dimples are not filled in, caulked or painted.

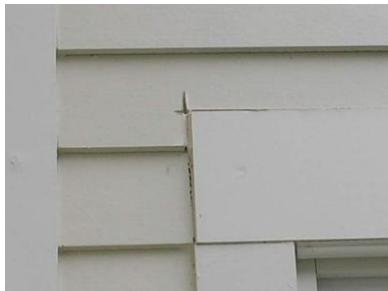
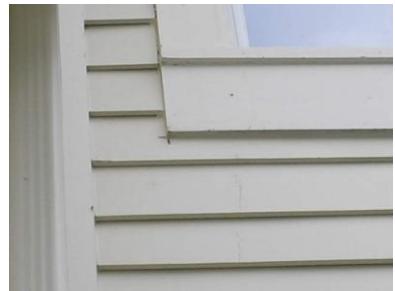
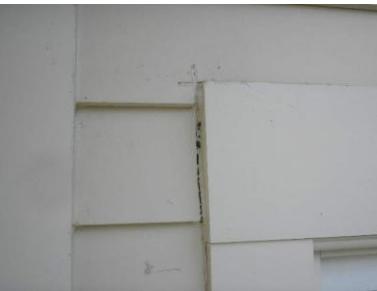
18.

- 17. There are open saw cuts in siding around some windows, like on the rear breakfast area and bonus room.

19. There is something sticking out at the top of the trim above the rear master bay windows outside.

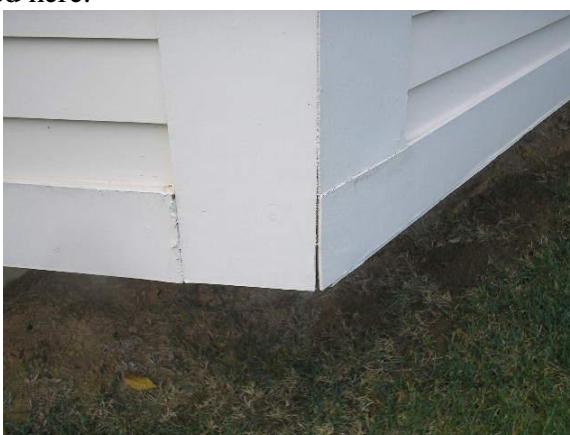
26.

24. Some spots of the MDF trim boards are puffed out by water; like at the bottom of the rear master bay bump out and at some nail holes.

25. Edge of the plywood is showing on the bottom of the rear master bay bump out. The trim usually runs down over the edge of the plywood on the bottom of the bay. This is one reason the MDF trim is puffed out from water trapped here.

27. Some seams have opened up on the wood on the corners of the rear master bay bump out.

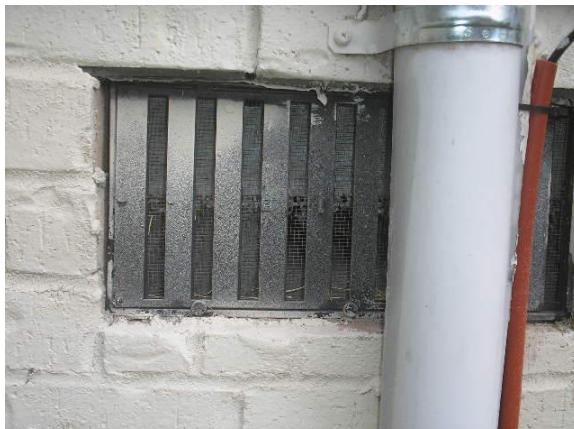
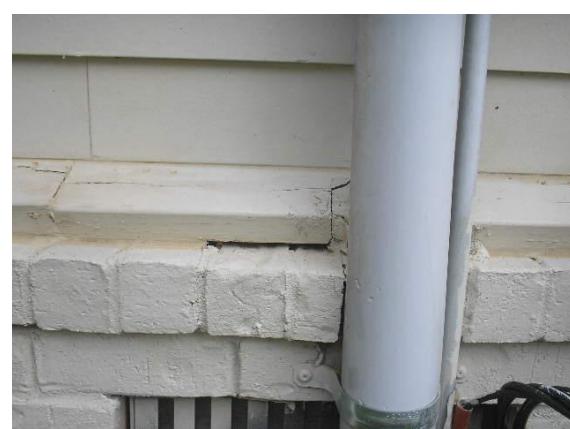
38.

36. There is a $\frac{1}{2}$ " gap between some of the boards on the right end of the front porch balcony.
37. House wrap is hanging down and covering some of the crawl vents; like on the left side of the house.

39. Finish caulking the wood trim board on the top of the brick ledge on the left end of the house by the electric service.

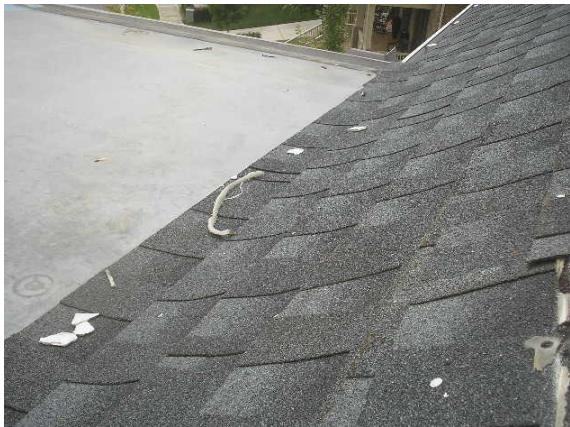
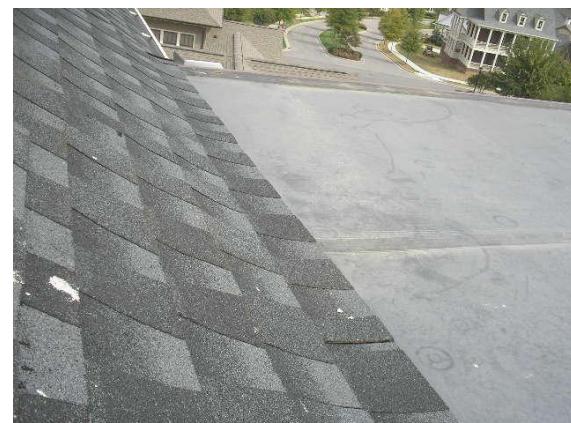
- 2.
3. Roof shingles have slid down and are just face nailed under the front attic dormer windows.
4. Remove debris and nails from roofs like seen out the front attic windows.

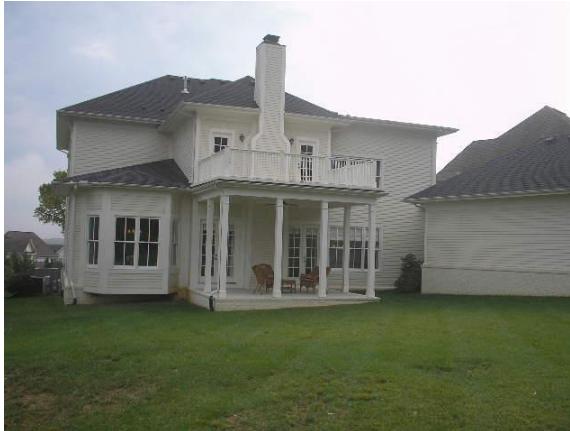
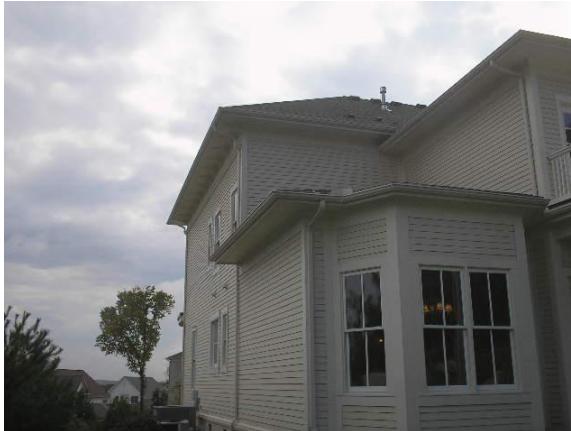
- 5.
6. Roof shingles are torn and not covering tops of the wood fascia boards on some corners; like on both front right corners. This can be seen with binoculars from across the street.
7. Roof shingle is torn and laying down in the gutter on the front right corner.
8. Roof shingle is raised up where a nail is backed out on the rear upper roof.
9. There are no roof vents or attic access to the area above the master bedroom.

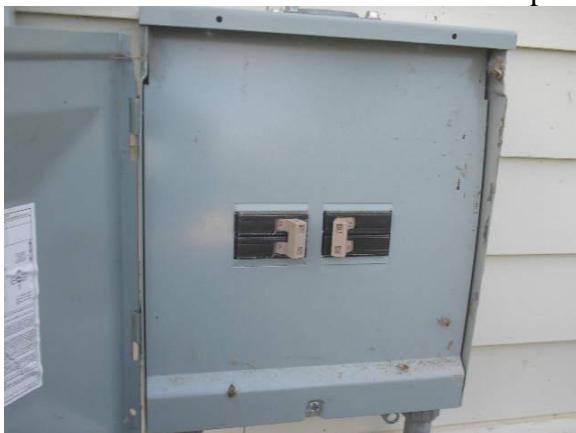
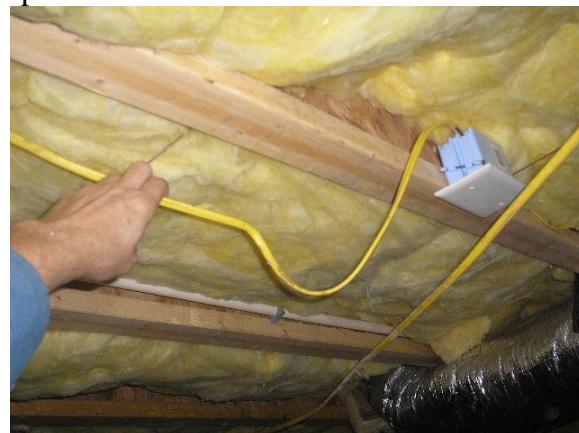
4. There is no outlet on the long bar top in the bonus room. There should be a GFCI protected outlet here.
5. In upper attic, the off/on switch is upside down on the disconnect on the HVAC unit. Down should be off even though it is labeled with a Sharpie.

6. Label the breakers in the outside electric panel per codes. There are no labels here.

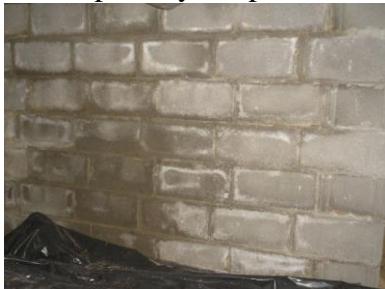
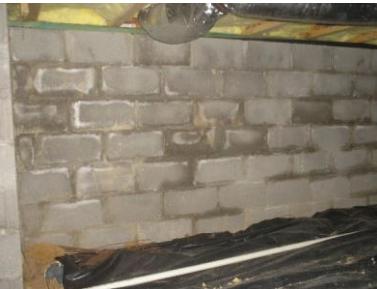
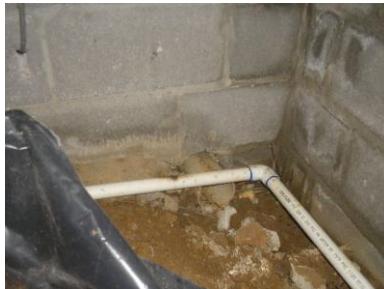
2.

1. Concrete block walls are damp and have efflorescence on them; like on the front wall of the crawl space by the planter, in both front left corners, on the left wall and across the rear wall.

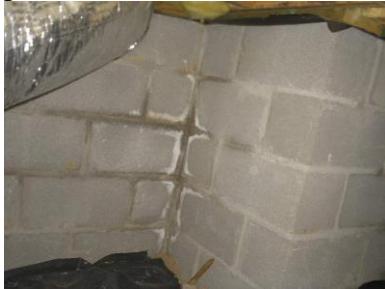
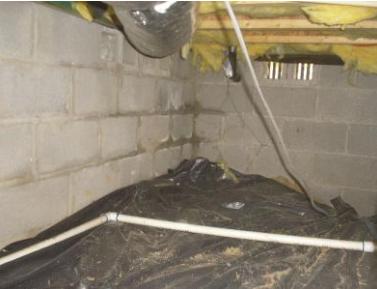
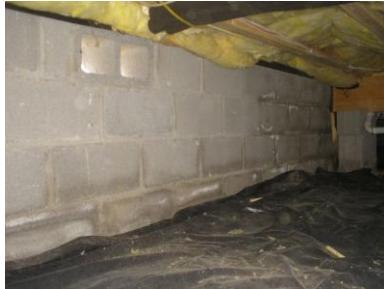
4.

3. Efflorescence typically occurs during the initial curing of masonry construction, particularly brick, when water moving through a wall or other structure, brings salts to the surface. As the water evaporates, it leaves the salt behind, which forms a white, fluffy deposit, that can normally be brushed off. It is common to see this in the crawl space walls behind outside porches.

5. Ground is soft and muddy in back of crawl space where outside ground slopes down to the trench along the back of the house.
